# Assessment of the Rehabilitation of Watercourses (Study Case)

**Abstract:** The goal of this study is to assess the rehabilitation of Bahr Awlad Mohamed canal. The canal was rehabilitated by installing lining trapezoidal cross-sections. Before and after the rehabilitation process, a field investigation, hydraulic and hydrographic measurements, and a mathematical model (Sobek – ID) were conducted. According to the findings, the canal's rehabilitation improved average water velocity from 0.18 m/s to 0.32 m/s, the average Manning roughness coefficient from 0.065  $m^{-1/3}s$  to 0.020  $m^{-1/3}s$ , the water surface slope from 17 and 50 cm/km to 2 and 6 cm/km, the average areas of cross-sections reduced from 3.37  $m^2$  to 3.07  $m^2$ , the average water width was reduced from 5.84 m to 4.83 m, the water losses were decreased by approximately 27.31 % from the canal's inlet discharge. Additionally, the water level fulfilled the requirements for water distribution, the canal banks were restored and widened, the hydraulic efficiency of the study canal was improved, alleviating downstream farmers' concerns and conserving water that could be utilized for irrigation, and saving time an

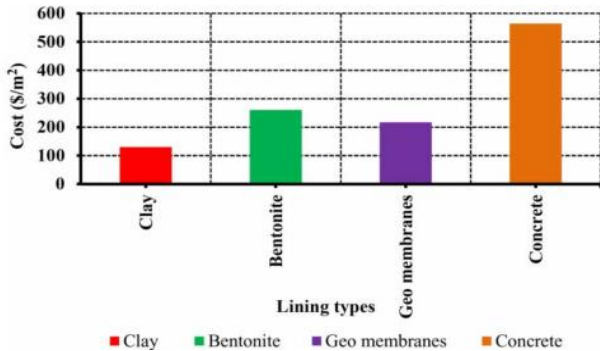
**Figure 1: Comparison between costs of different lining materials**

Vegetation growth is more obvious in clear water, however, nutrients in water with sediment may promote weed growth. The type, height, density, and flexibility of the vegetation, as well as submerged or non-submerged conditions, water level, and flow velocity, all influence vegetation blockage. The flow velocity decelerated in vegetation zones but accelerated and deviated toward the opposite bank in non-vegetated zones [18]. According to the comparison in figure (1), geomembrane is the best lining material since it reduces pollutant extension by 91 percent at a lower cost than concrete, which reduces contaminant extension by 93 percent at double the cost of geomembranes [19].

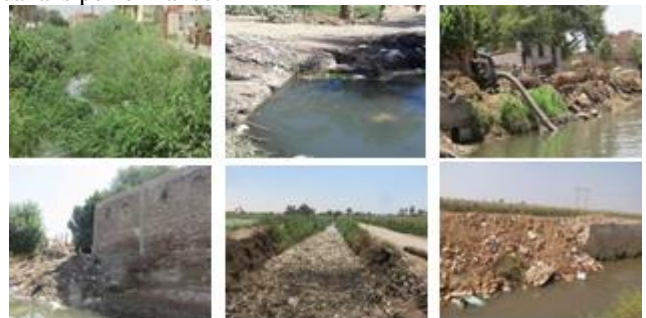
**Photo 1: Bahr Awlad Mohamed Problems before rehabilitation**

As shown in photo (1), some issues were discovered during the canal investigation before rehabilitation, including the spread of aquatic weeds and solid wastes, the illegal use of irrigation water pumps due to low water levels, unfair water distribution, water user encroachments, water seepage, deterioration of sub-branch canal inlets, water shortages, decreasing water conveyance to the canal's end, narrow canal banks, irregular cross-sections, and the presence of illegal irrigation water openings, all of which harm the canal's performance.

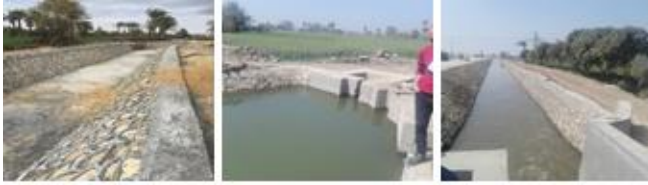
Photo 2: Bahr Awlad Mohamed after rehabilitation

As shown in photo (2), after the canal was rehabilitated, the lined cross-sections were regular and reduced in size, the aquatic weed infestation was reduced, the canal's banks were increased and levelled, the sub-branch canal's inlets were improved, water conveyed easily to the canal's end, water entered the sub-branch canals by gravity without the use of illegal pump units for irrigation, the illegal irrigation openings were closed, and the farmers complain were decreased.

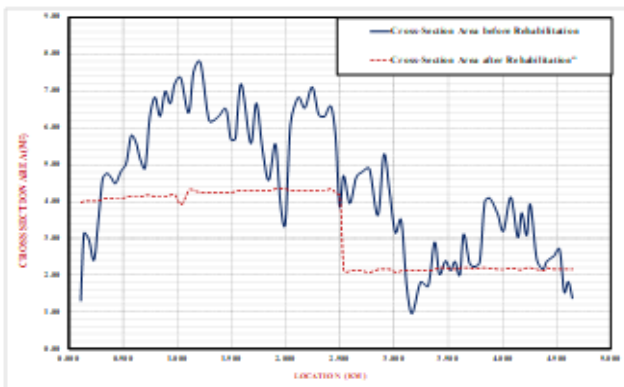
Figure 3: Cross-Section Area before and after rehabilitation

The hydraulic parameters were determined before and after rehabilitation processes as shown in table I, table II, and figures (3 to 5).

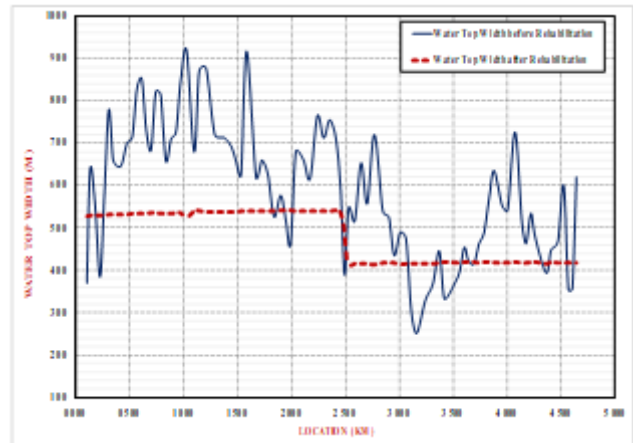
Figure 5: Water Top Width before and after rehabilitation

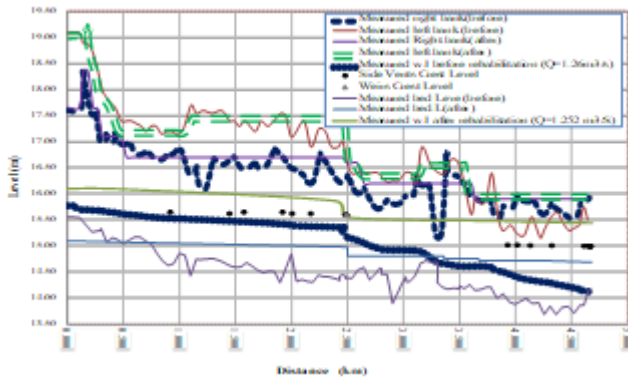
Figure 7: Measured Longitudinal Cross-Section before and after rehabilitation

Before and after rehabilitation cases, 88 cross-sections and longitudinal cross-sections were surveyed and plotted every 50 meters. The comparison of the two cases in Figures 6 and 7 indicated that before rehabilitation, many sites' cross-sections were much wider, the bed and the two banks were irregular, the removal of around 14728 m<sup>3</sup> of sediments to restore the designed sections were required, and the water surface level was below the sub-branch canals' inlets which obliged the farmers to use the pumps for irrigation.

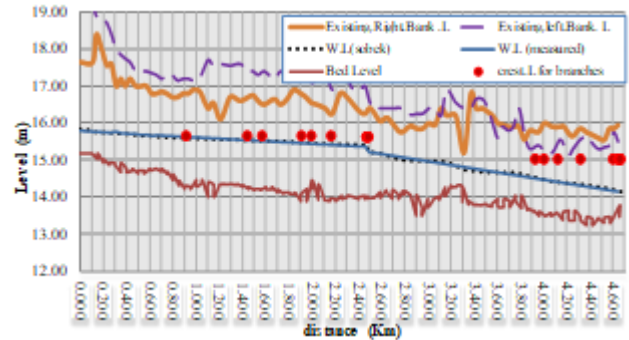
Figure 8: Mathematical Model Calibration for the canal

cross-sections, inlets of sub-branches, and the hydraulic structures were simulated in the model. In the case of the canal before rehabilitation, the model was calibrated using a 1.26 m<sup>3</sup>/s water discharge at the canal inlet and a water level of 14.15 m at the canal's end, as shown in figure (8), and verified using a measured 1.03 m<sup>3</sup>/s inlet discharge with measured 15.50 m water level at the end of the canal as in figure (9), which shows the convergence of the results between the measurement in nature and the model. In the model, scenarios of delivering the measured discharges with the water levels at the canal's ends in the two cases were run, as illustrated in figure (9). The findings revealed that the water depth was improved after rehabilitation to cover all of the sub-branch canal weir crests inlets by 40 to 50 cm and meet the levels for water distribution to inter the sub-branches by gravity without depending on illegal pump units for irrigation, as well as an increase in the freeboard between the water levels and the two banks.

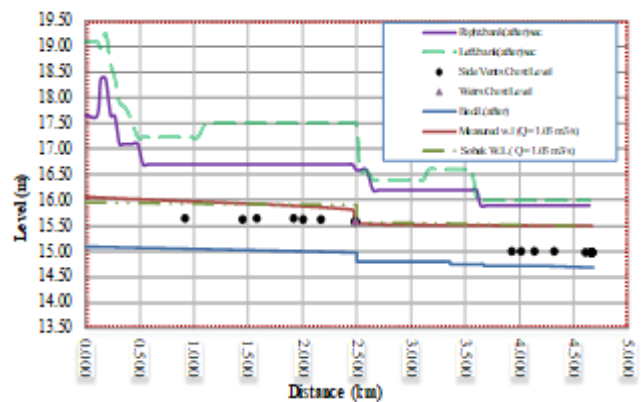
Figure 9: Mathematical Model Verification for the canal

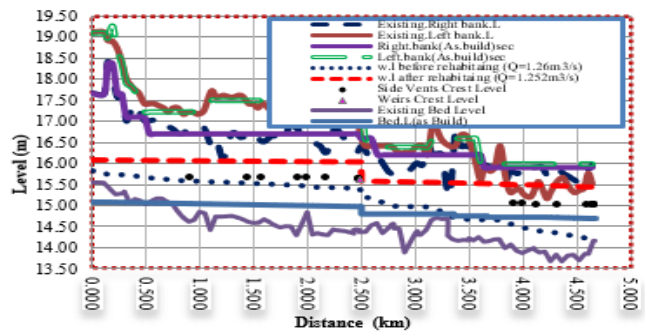
Figure 10: The Water level in the model before and after the canal rehabilitation
